TRANSACTIONS  
OF THE  
INTERNATIONAL  
ENGINEERING CONGRESS, 1915

THE PANAMA CANAL

I. GENERAL PAPERS AND CONSTRUCTION IN THREE DIVISIONS OF CANAL

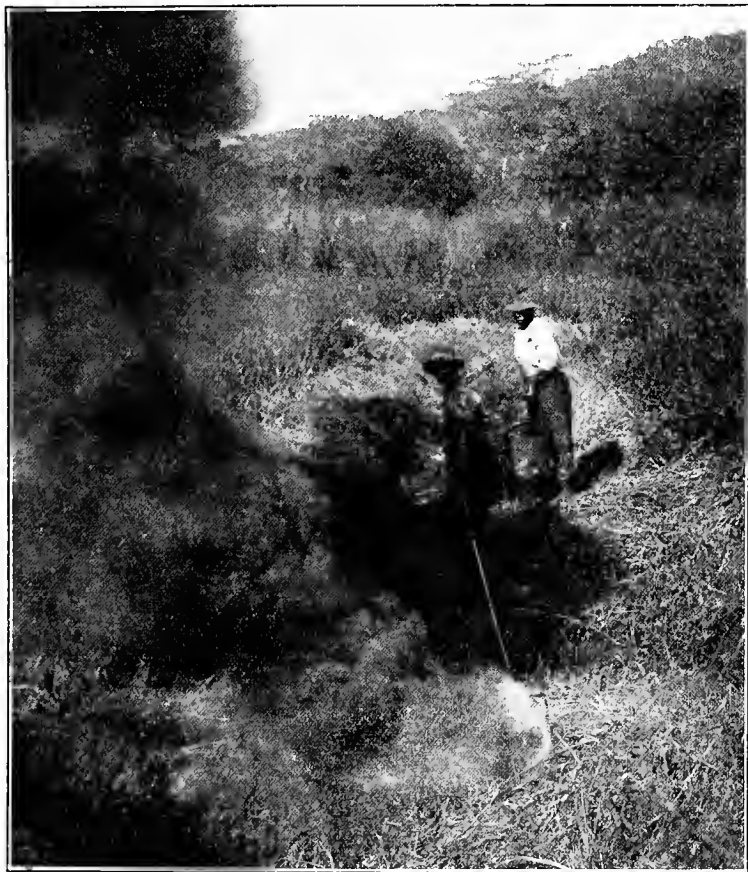
Fig. 3. Burning Grass from Side of Ditch, Crude Oil used as Fuel.

pump is fitted with about fifty feet (15 meters) of rubber hose, at the end of which there is inserted about six feet (1.8 meters) of one-half inch (1.27 centimeters) metal pipe with a spray nozzle at the end. (Figure 3.)

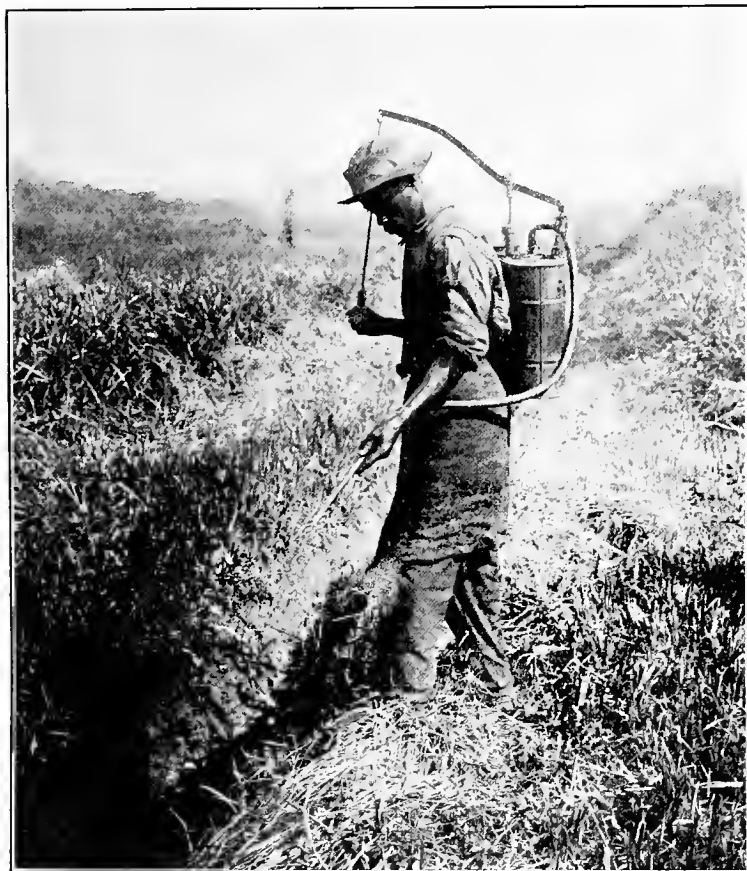
Fig. 7. Application of Larvicide (Mosquito Oil) by use of Knapsack Sprayer.

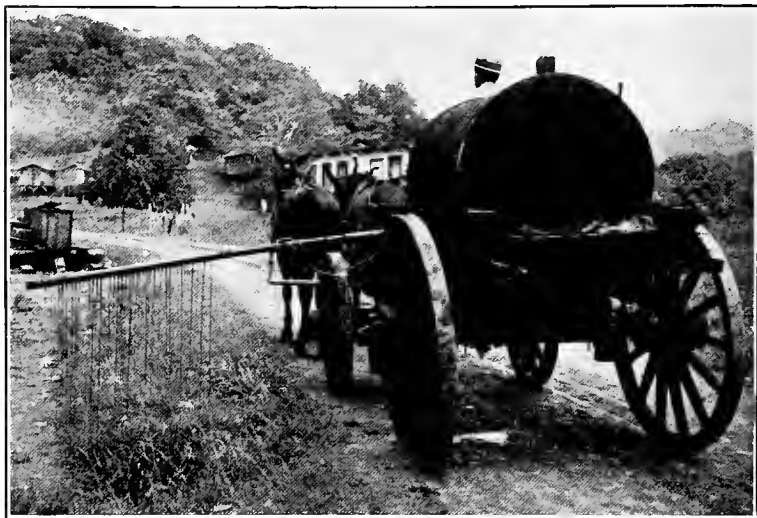
Fig. 8. Wheeled Ditch Oiler.

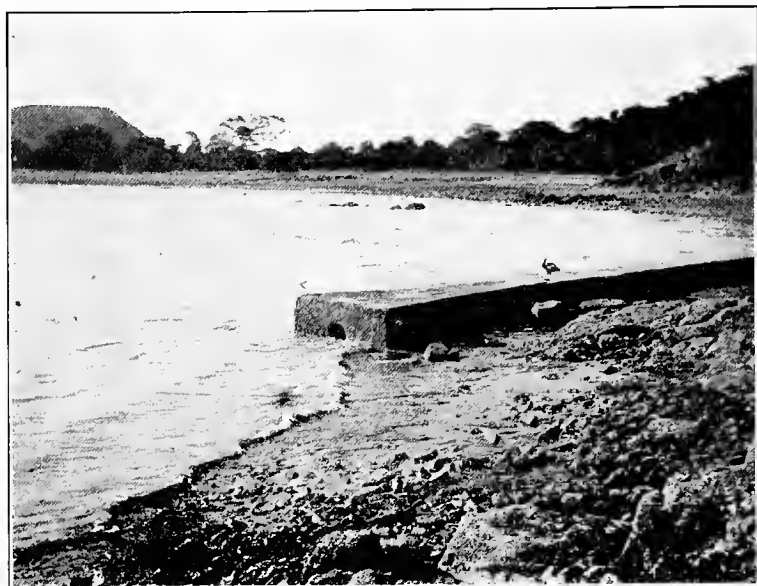
Fig. 2. Western Outfall at Half Tide.

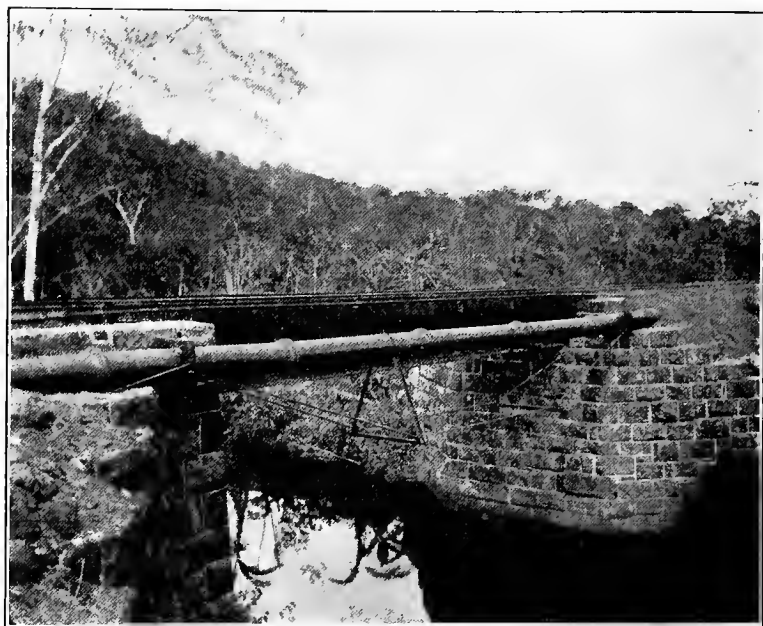
Fig. 5. 16-inch Cast Iron Pipe Supply Line. A Stream Crossing.

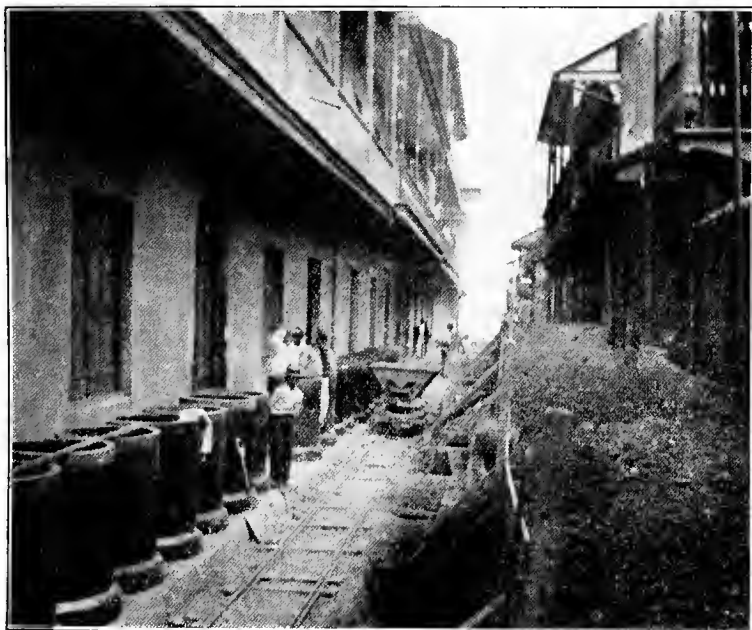
Fig. 13. Crowded Conditions on a Narrow Street. Deep Trenching on Avenue A\* for the 24-inch Sewer.

trench adjacent to the building then occupied as a residence of the chief engineer, caving developed, and it was necessary to keep a gang at work continuously for two days in order to protect the sides, shore the adjacent buildings and prevent damage. Later, in the construction of one of the storm overflows, which was built by tunneling near the ice plant, a second bad case of settlement happened, due to the buildings in the vicinity having been constructed on ground previously made

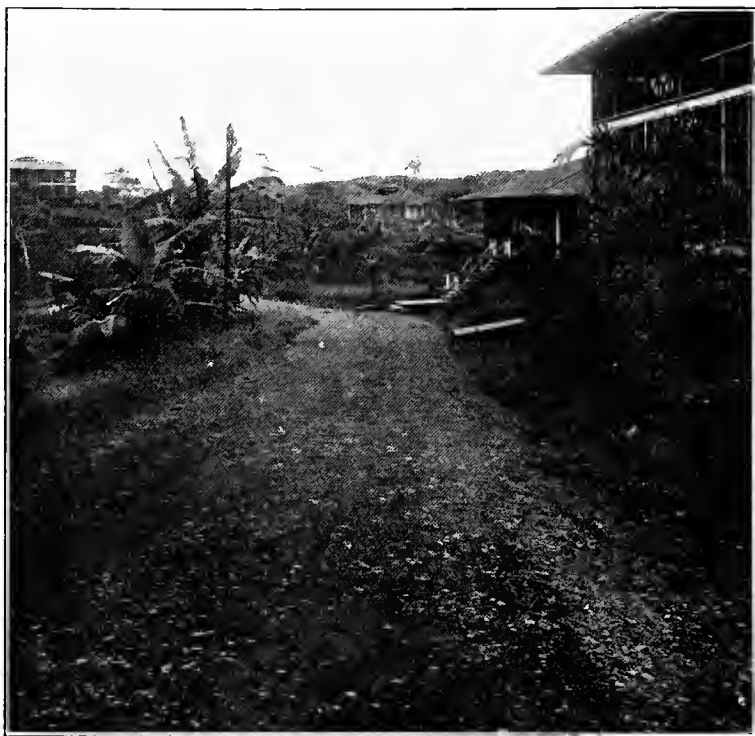
Fig. 1. Water-bound Macadam Road after Three Years of Service without Repairs.

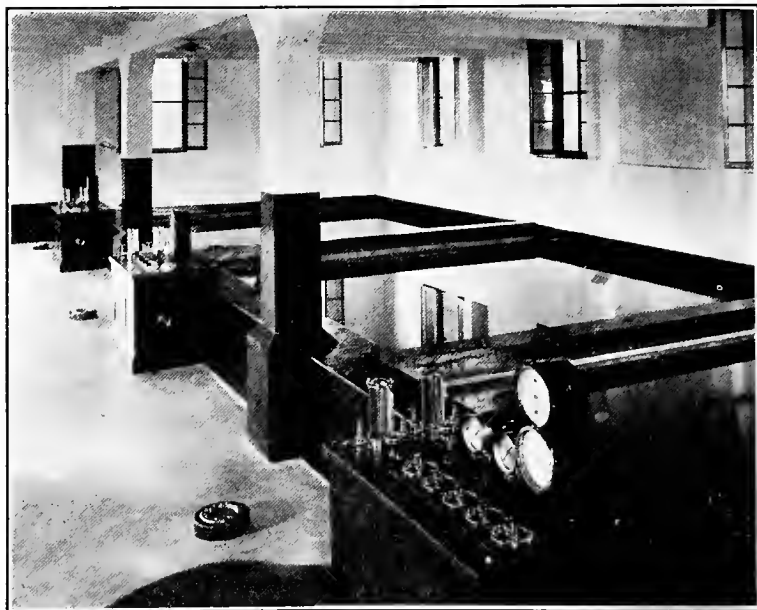
Fig. 6. Mount Hope Filtration Plant. Partial Interior View Showing Filters.

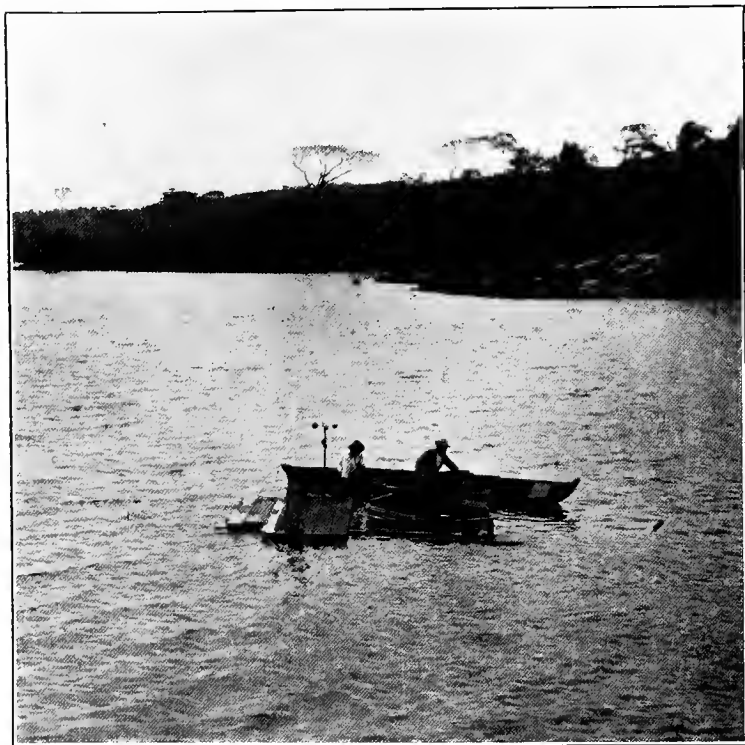
Fig. 16. Evaporation Pan, Gatun, 1914.

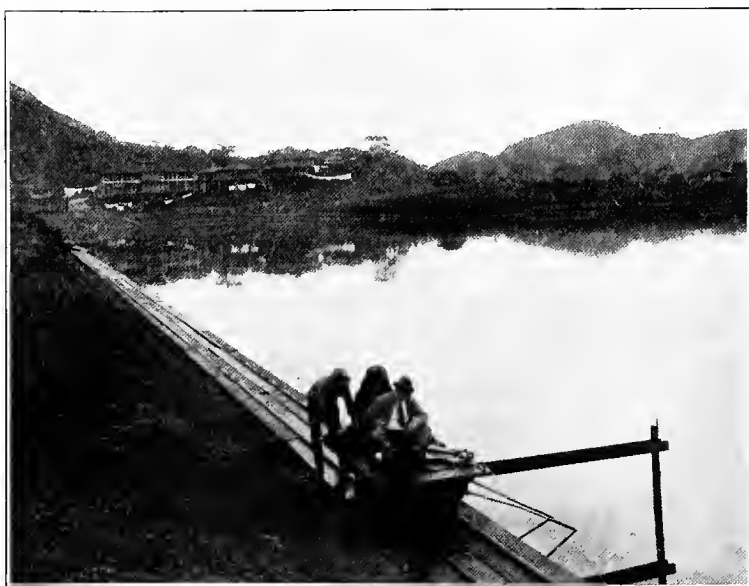
Fig. 20. Current Meter Rating Station, Pedro Miguel.

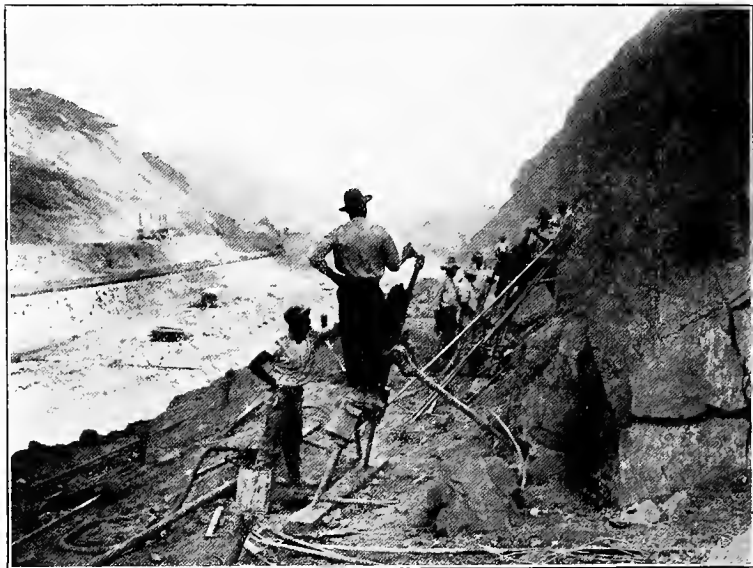
Fig. 1. Culebra Cut, Culebra. Air Drills on Side of Contractor's Hill, Looking South. January 1912.

The steam drills turned over by the French were replaced as new ones could be secured, and these were of the tripod and churn or well-drill types. The tripod drills were fitted for working with air at 90 pounds pressure, and those in general use were fitted with  $3\frac{5}{8}$ -in. cylinders to drill 24-ft. holes 2 in.

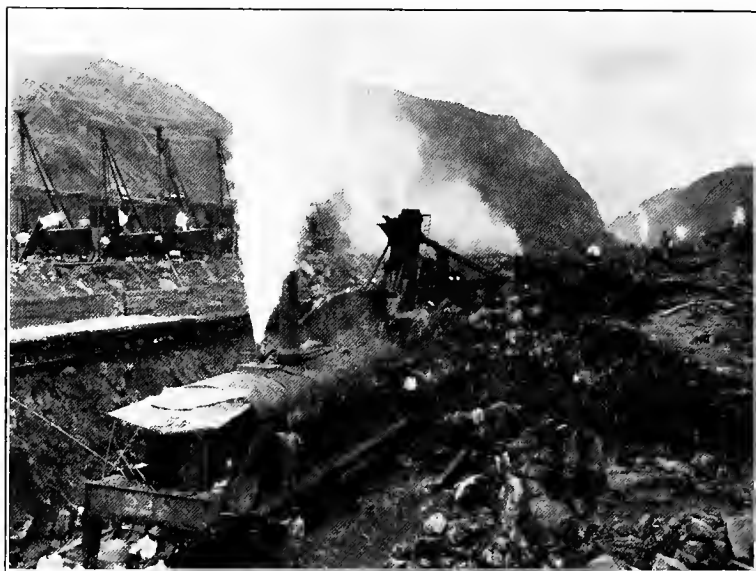
Fig. 3. Culebra Cut. Completion of Bottom Pioneer Cut. Steam Shovels Meeting at Grade. May 1913.

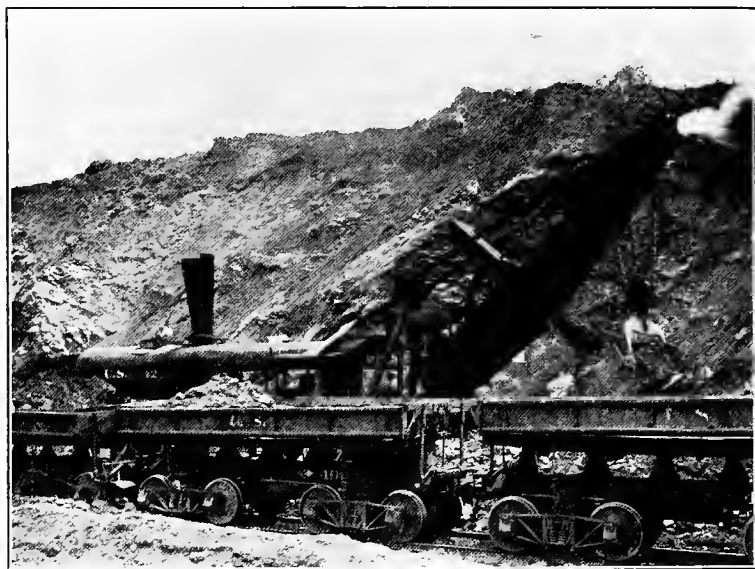
Fig. 5. Steam Shovel Loading Oliver Dump Cars, East Bank of Cut North of Gold Hill. March 1914.

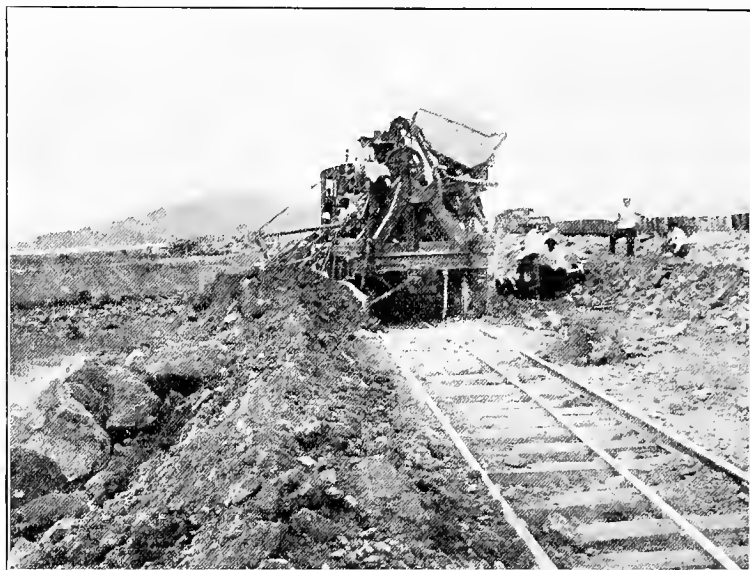
Fig. 7. Spreader at Work on the Naos Island Breakwater.

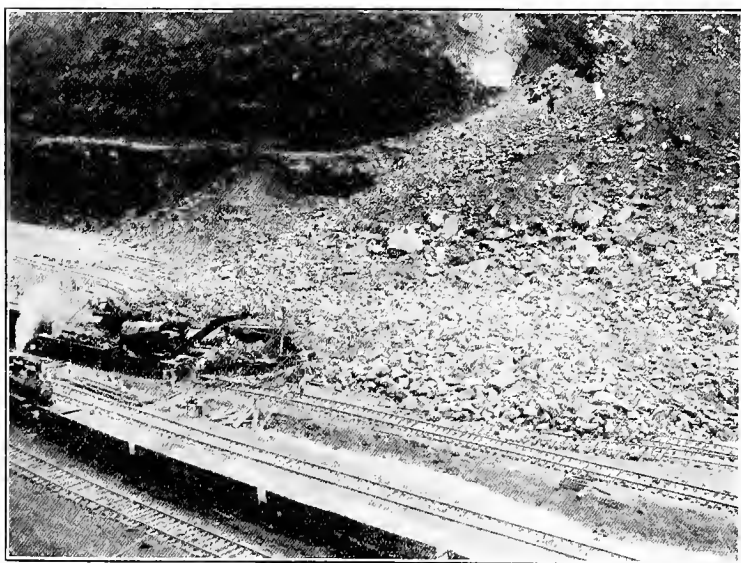
Fig. 10. Culebra Cut. Rock Slide South End of Gold Hill. August 1913.

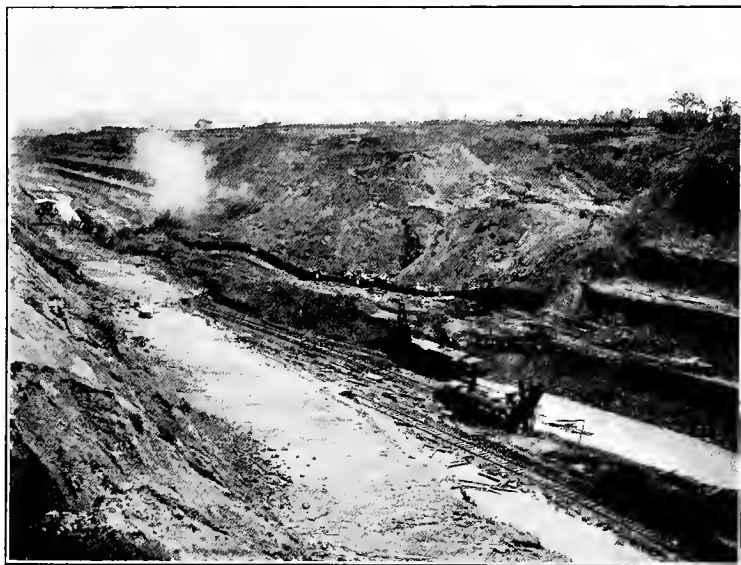
Fig. 11. Culebra Cut, Culebra. Break in East Bank between Stations 1746-1748. General View from West Bsnk. May 1913.

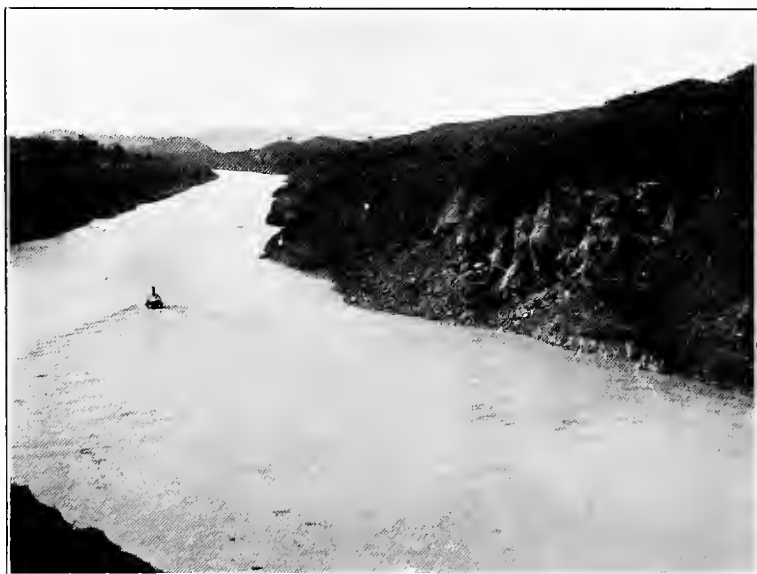
Fig. 13. Culebra Cut, Empire. Rock Slides on East Bank of La Pita Point. Nov. 1914.

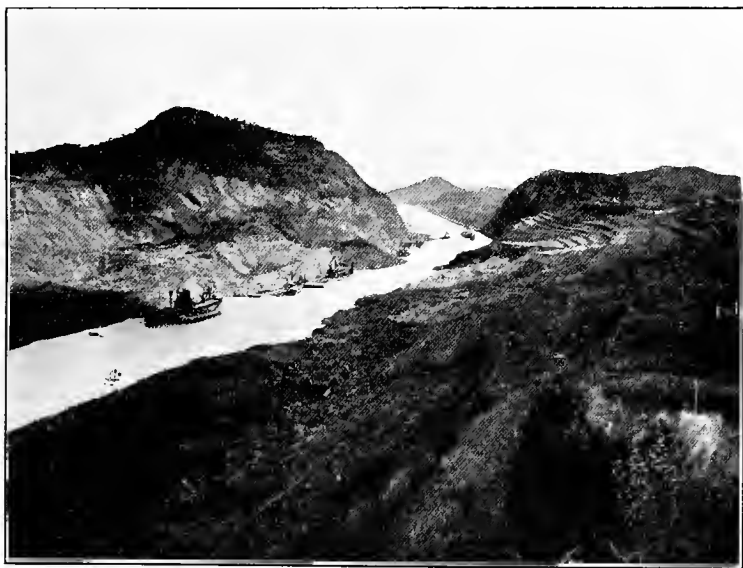
Fig. 16. Culebra Cut, Culebra. Looking South from West Bank, showing Condition of Both Banks. February 1915.

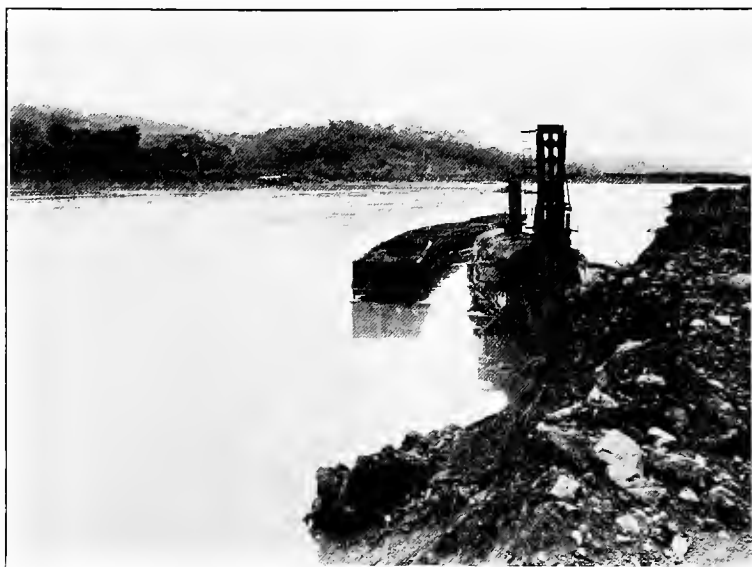
Fig. 17. The Cut at Calmito During Flood of June 15, 1909.

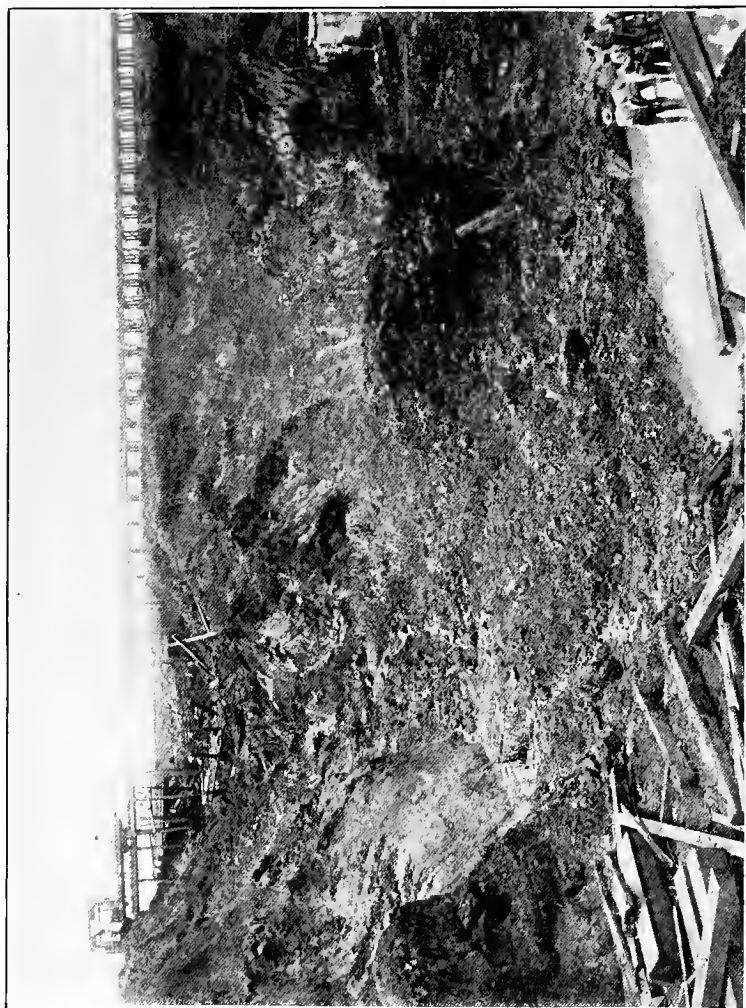
Fig. 1. Slide in North End of East Bank of Gatun Lower Locks, May 15, 1911.

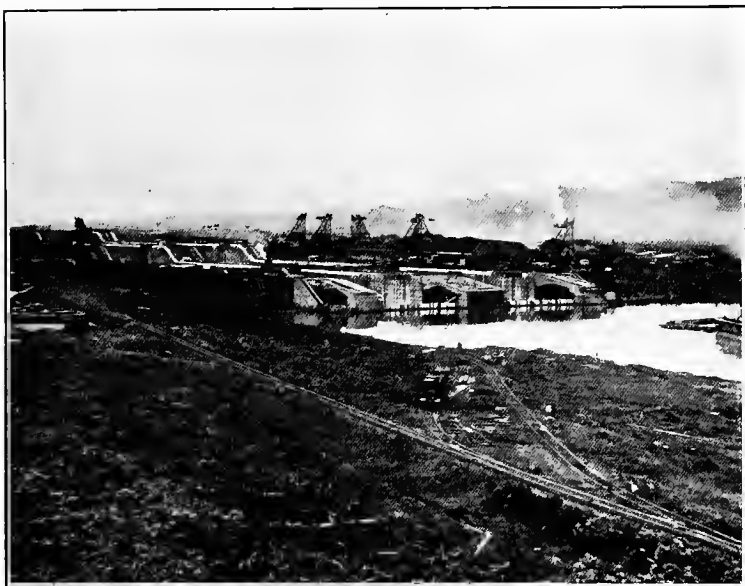
Fig. 2. General View of Gatun Locks, Showing North End of Locks with Temporary Cofferdam in Place.

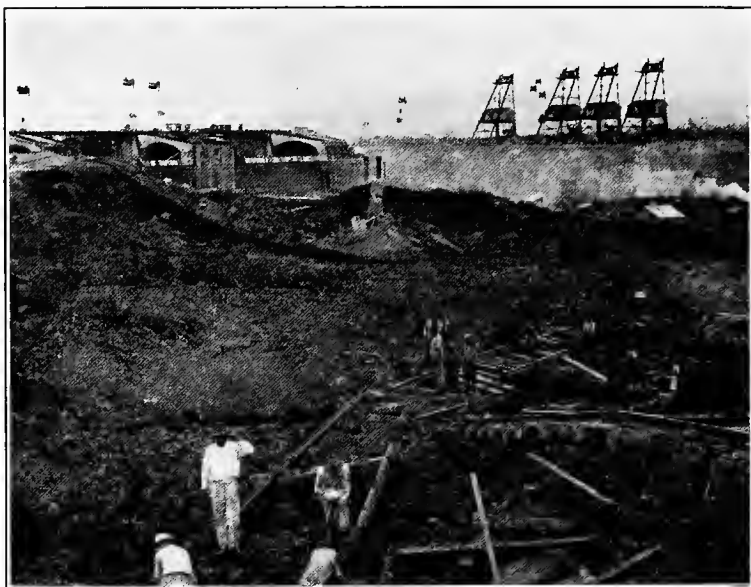
Fig. 3. Slide in East Bank at North End of Gatun Lower Locks, Jan. 25, 1913.

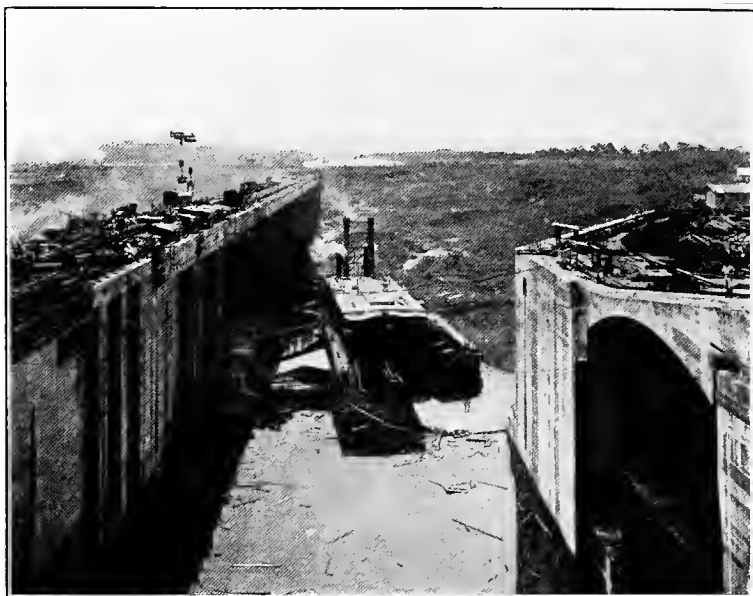
Fig. 5. North Approach Wall of Gatun Lower Locks. Dredge Grounded 55 Ft. below Sea-level.

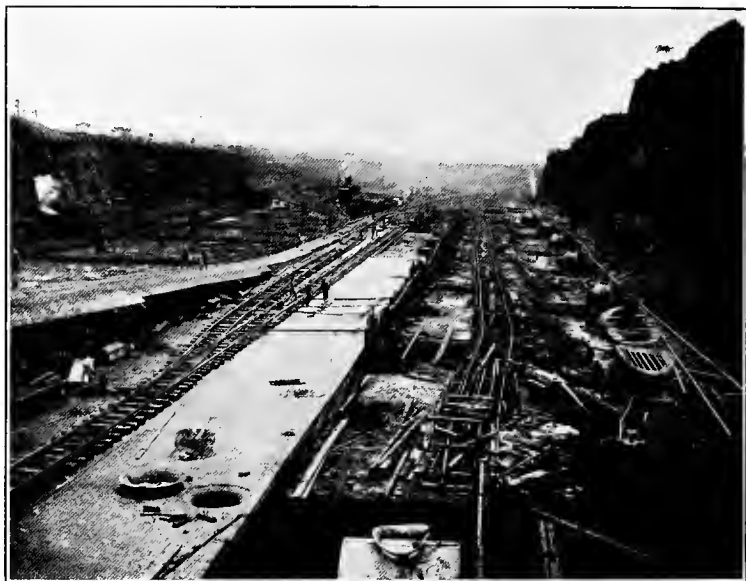
Fig. 10. Gatun Middle Locks, Showing Forms for Culverts.

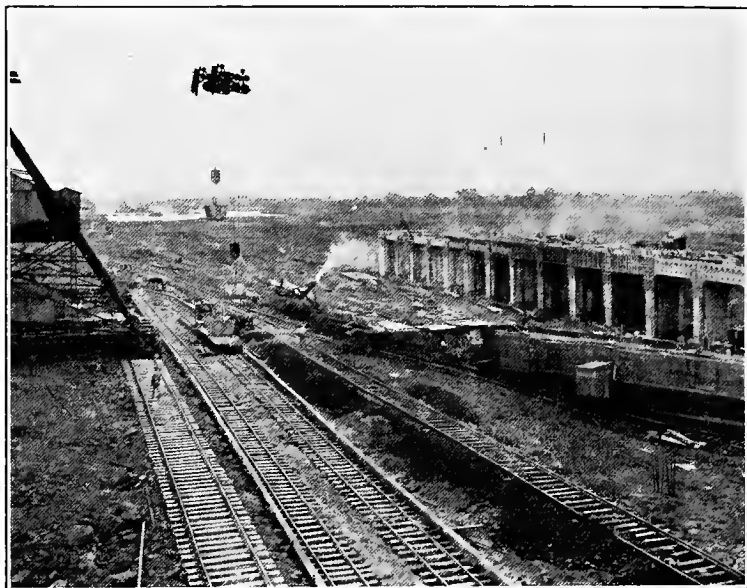
Fig. 11. Construction of Guard Wall at North Entrance of Gatun Lower Locks.

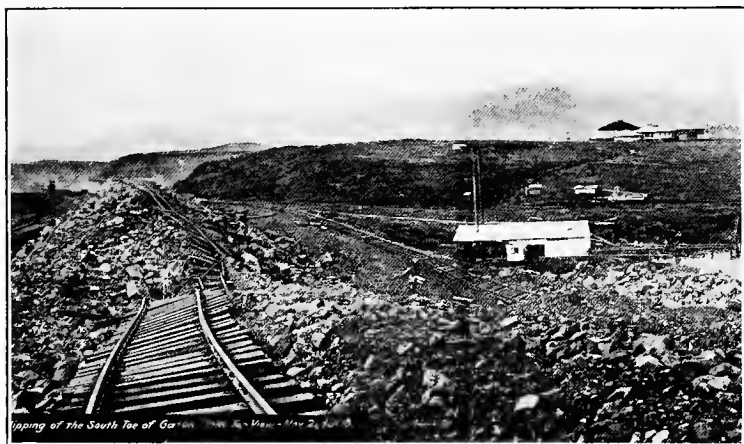
Fig. 15. Slipping of South Toe of Gatun Dam, Nov. 21, 1908.

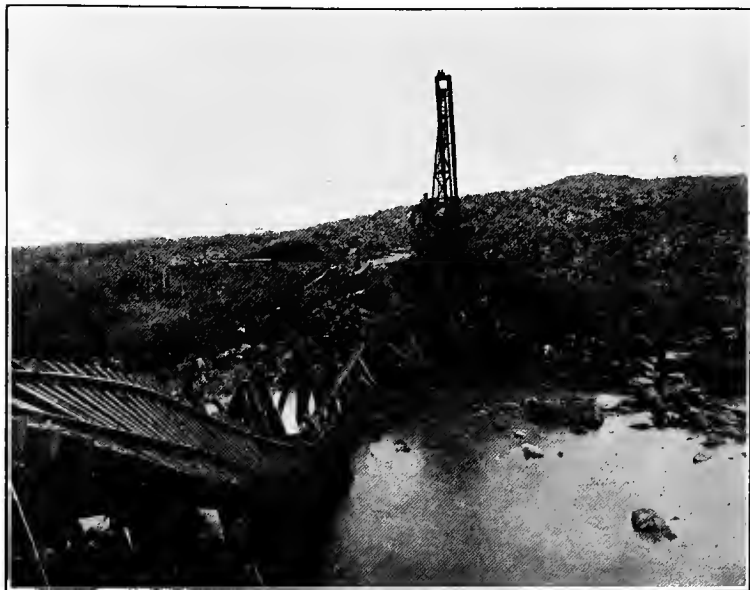
Fig. 19. Slide During Construction of Gatun Dam.

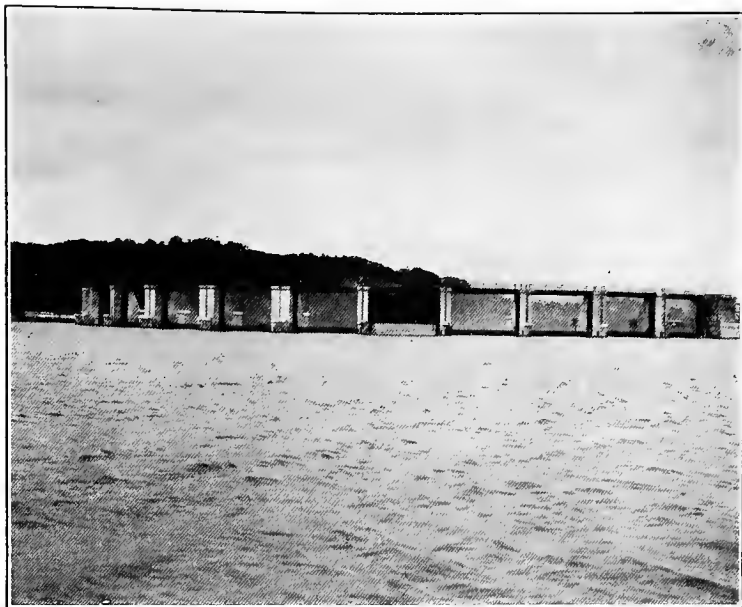
**Fig. 21. Upstream Side of Gatun Spillway Dam.**

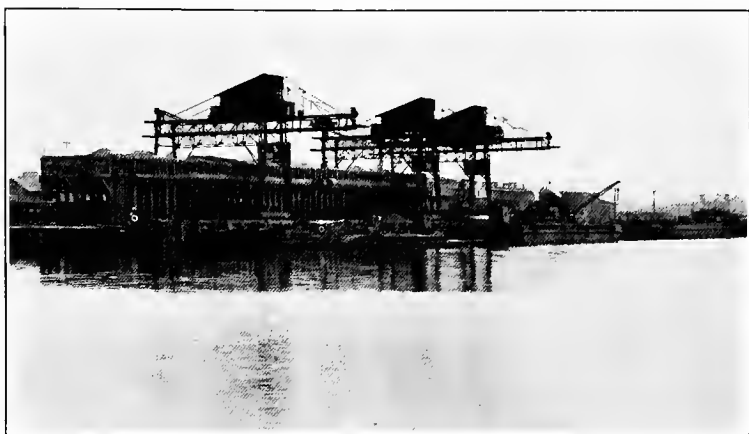
Fig. 2. Sand Unloading Cranes at Balboa.

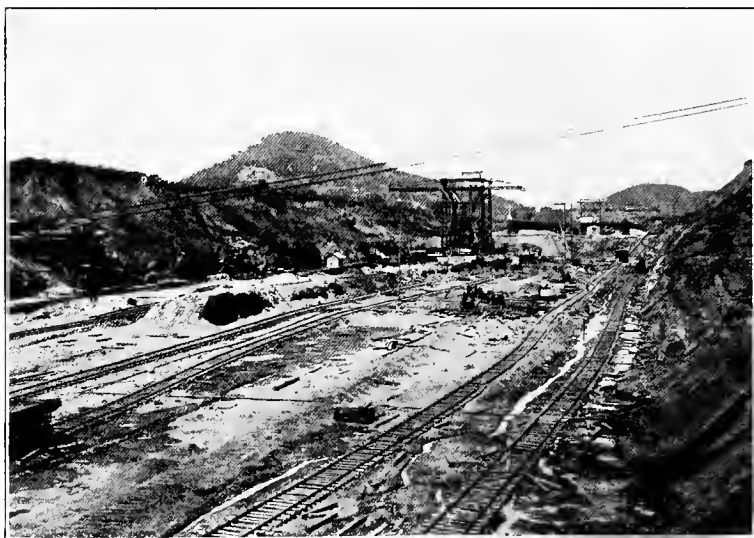
Fig. 3. Pedro Miguel Locks. Looking North from East Bank.

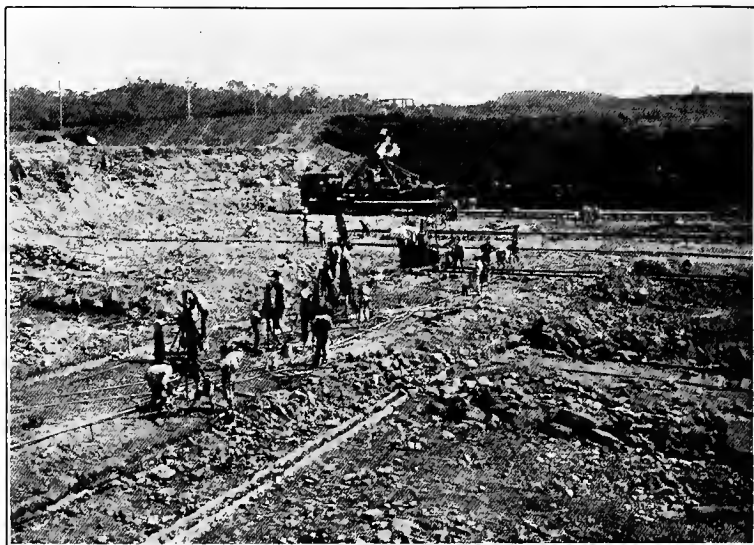
Fig. 4. Excavation at North End of Upper Miraflores Locks.

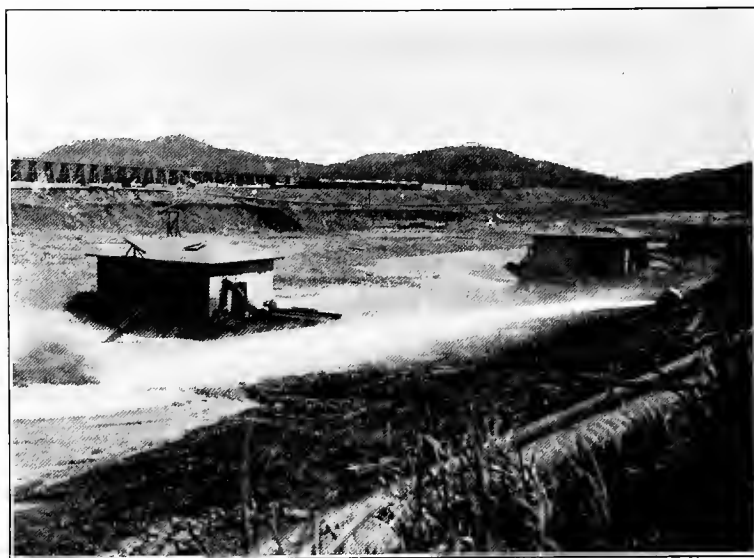
Fig. 10. Hydraulic Excavation, Miraflores Dredging Barges.
